Manhole Inspection Summary

Manhole # S45C__016MH

Insp Date: **8/18/08 9:14 AM**

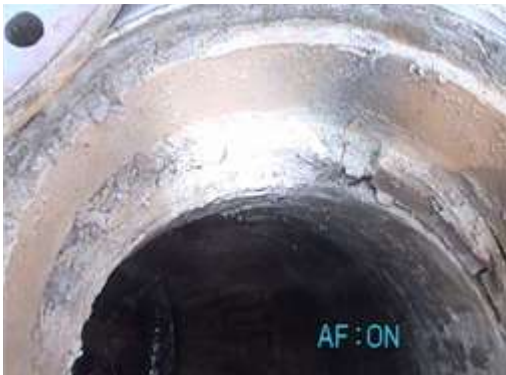
Defect 1

Infiltration: ☐ None ☐ Joint ☐ Cracks ☒ **Mortar** ☐ Roots ☐ Wall

Infiltration: ☐ None ☐ Joint ☐ Cracks ☐ Mortar ☐ Roots ☒ **Wall**

Infiltration

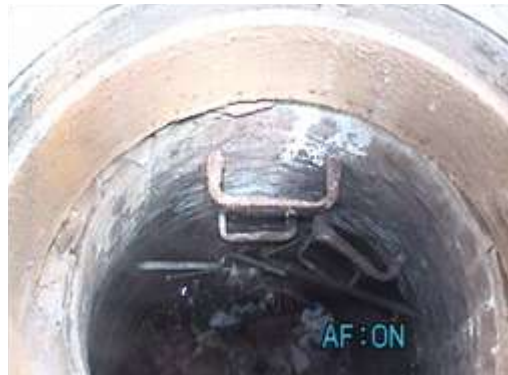
Defect 2

Frame Offset: **3** (in.) Condition: ☐ Sound ☐ Cracked ☒ **Leaks**

Frame leaks

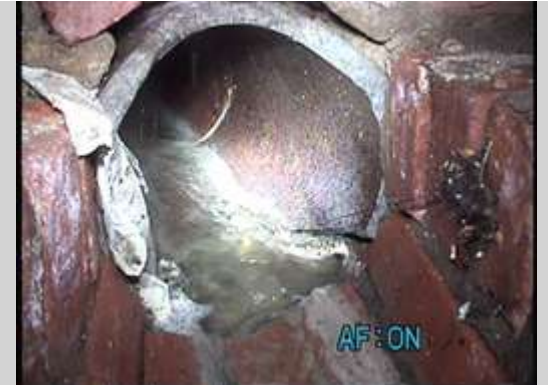
12 O'Clock Outflow

8 in. Circular Gravity Sewer
Pipe Out @ 12 O'Clock

Pipe Height: **8.4** (in.) Rod and Bar (Angled)
Pipe Material: **Clay** ☐ Pipe Lined
Invert Depth: **9.45** (ft.) Flow Characteristics: **Fast**
Deposits: ☒ None ☐ Mud ☐ Sludge ☐ Debris ☐ Grease
Silt Depth: (in.) Deposits Extent:
Infiltration: **None** Pipe Seal Cond: **Sound**

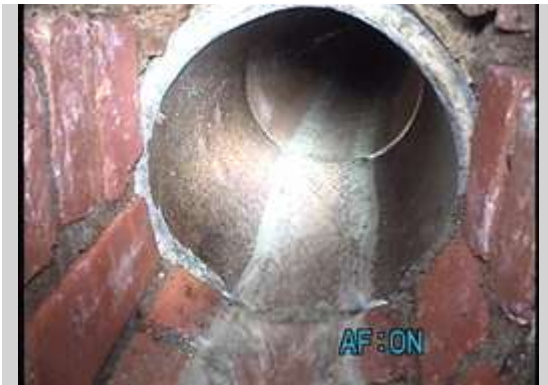
9 O'Clock Inflow

8 in. Circular Gravity Sewer
Pipe In @ 9 O'Clock

Pipe Height: **8.4** (in.) Rod and Bar (Angled)
Pipe Material: **Clay** ☐ Pipe Lined
Invert Depth: **9.35** (ft.) Flow Characteristics: **Fast**
Deposits: ☒ None ☐ Mud ☐ Sludge ☐ Debris ☐ Grease
Silt Depth: (in.) Deposits Extent:
Infiltration: **None** Pipe Seal Cond: **Sound**
